Ventilation Survey

Graceville State School

Department of Education

13 April 2022

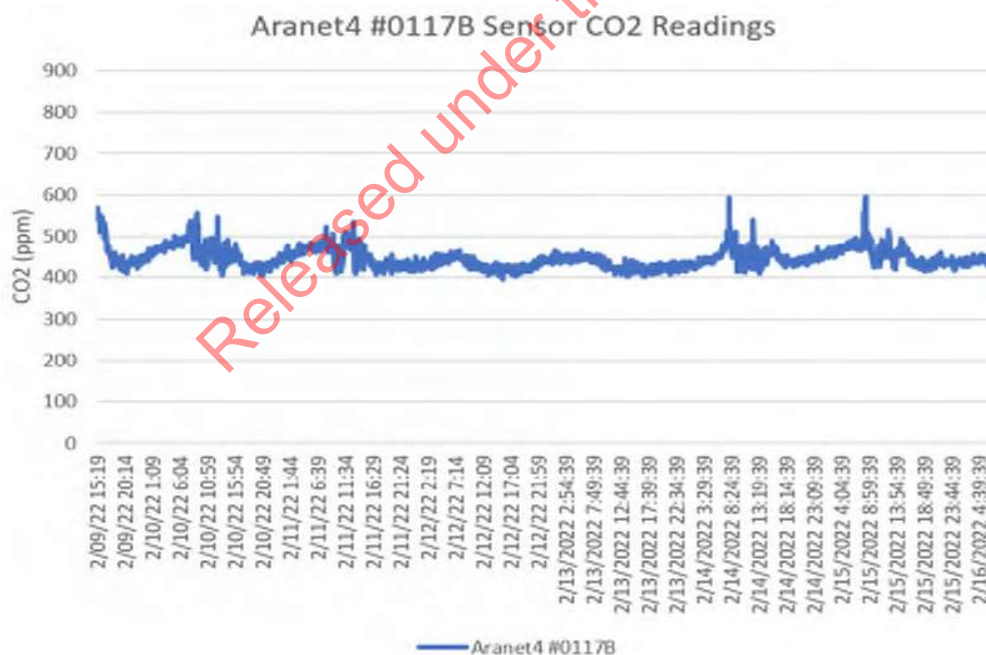
Figure 1 RG00N01 CO₂ levels

An Aranet4 logger was left in Classroom RG00N01 (N Block) at the request of the teacher. The windows on the field side of the class are often kept closed to minimise noise in the classroom while children are playing on the field. The logger was installed during the inspection on 09 February 2022 and removed on 16 February 2022. During this time, the CO₂ levels did not exceed 657ppm (16 February 2022 at 08h19). Refer to Figure 1 below.

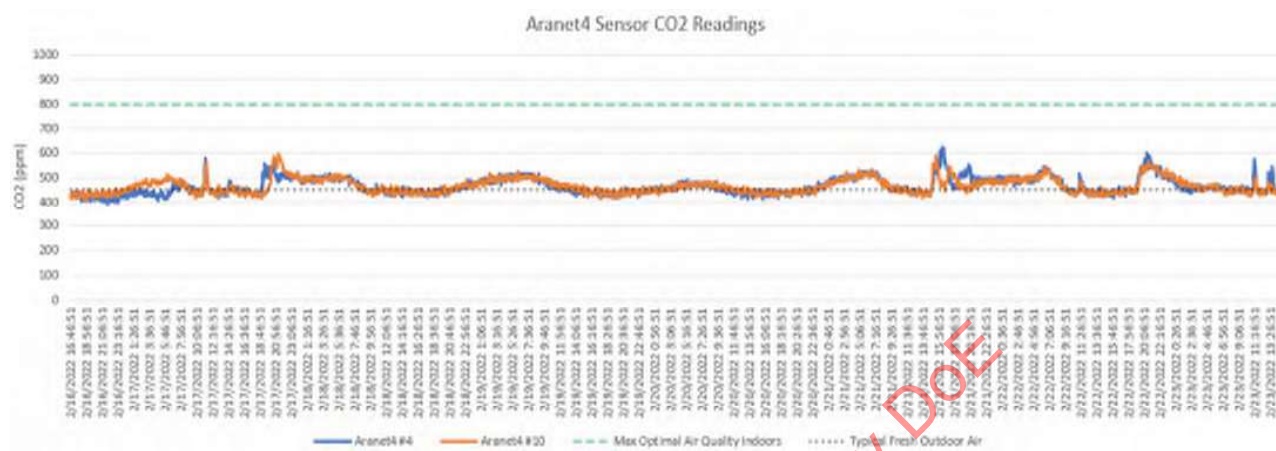
Figure 2 Hall CO₂ levels

As can be seen from the below, CO2 levels did not exceed 800ppm during the time installed.

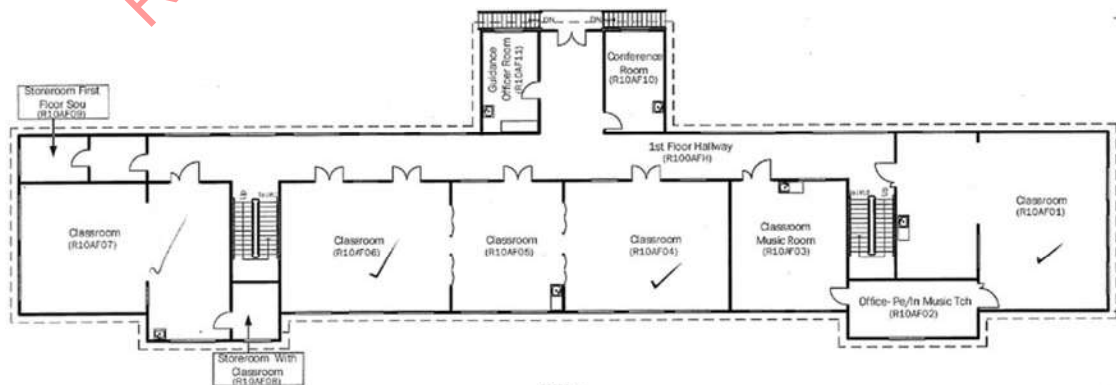
Figure 1 – A Block Level 01 Layout

The HVAC systems in A Block consist of wall mounted split units that cool the classroom, with the exception of R10AF07 which contains a window-wall unit that appears to be redundant and a wall mounted unit. There are no fresh air fans installed to A Block. The A Block classrooms rely on natural cross ventilation to ensure adequate fresh air supply to the classrooms, with openable doors and windows on opposite sides of the classrooms.

During the inspection of A Block, CO₂ levels over 800 ppm were found in half of the classrooms in A Block. The classrooms with CO₂ levels over 800 ppm were R10AF06, R10AF07, R20AS01 and R20AS03 with CO₂ level reading of 928 ppm, 873 ppm, 1428 ppm and 948 ppm respectively.

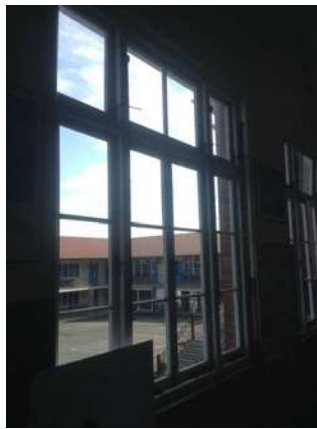
Figure 2 – A Block Hallway Window

The classrooms of A block open out to a common hallway on level 1 (R100ARH) and level 2 (R200ASH). It is noted that windows in the hallway are often closed because of aged and broken opening mechanisms. These windows are zip tied to prevent mechanisms moving from natural forces. The other openable windows in the hallway were found to be difficult to open. Furthermore, due to the absence of window overhangs and louvres, it was reported that windows typically remained shut on rainy days due to the potential rain ingress. It is suspected that combination of closed doors and / or windows hampered natural cross ventilation and resulted in the higher CO₂ levels.

All windows in A Block in both classrooms and hallways must be inspected and repaired to ensure they are easily operable.

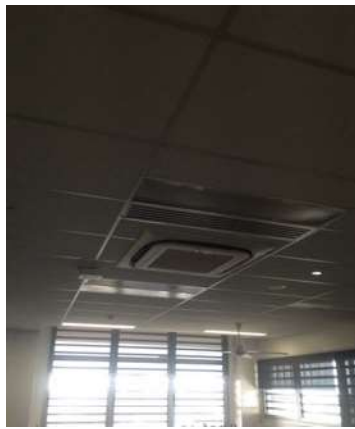
Figure 4 – C Block AC Cassette with Fresh Air Grilles

The HVAC systems in C Block consist of cassette split units that cool the classroom and ducted ceiling mounted fresh air fans, interlocked with the air conditioning units, that supply outside air to the classrooms when running.

During the inspection of C Block, a CO₂ level over 800ppm was noted in R30C304 with a CO₂ level of 1050 ppm.

All classrooms in C Block with the exception of R30C304 had windows and / or doors opened. These classrooms had CO₂ levels readings under 800 ppm. R30C304 was the only classroom with both the windows and door closed, and as a result this hampered outside fresh air entering the room. Furthermore, it was noted that the air conditioning units in R30C304 appeared to be operational, but the same could not be said for the fresh air fan. Fresh air fan operations could not be verified. With all doors and windows closed and no relief of supplied air, it is suspected that a lack of adequate natural or mechanical cross ventilation resulted in the high CO₂ levels observed.

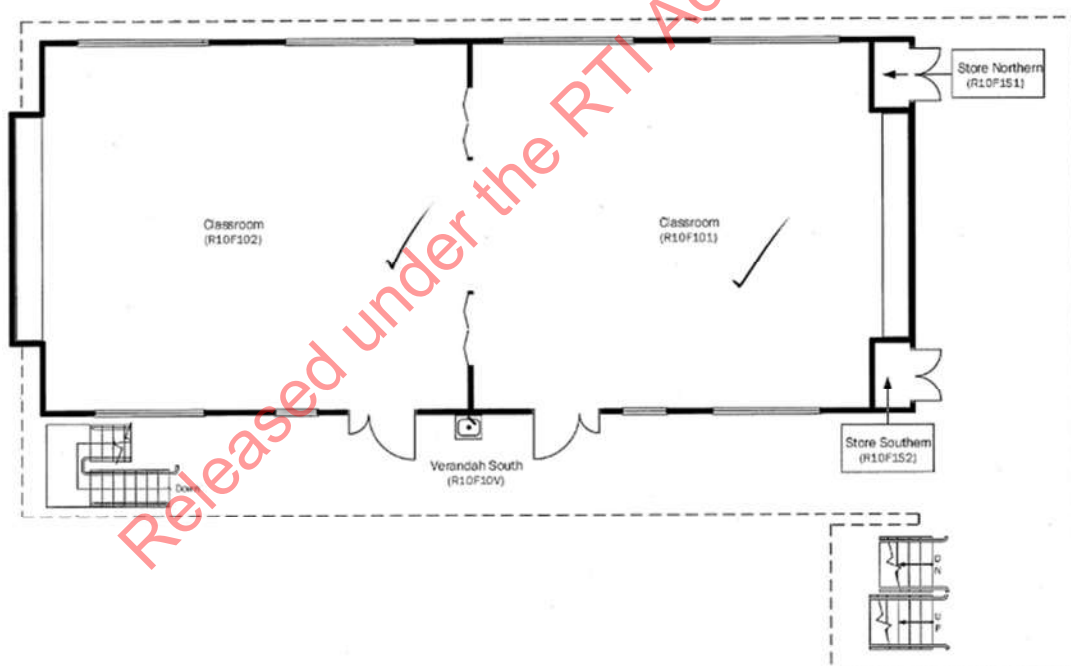
Figure 6 – F Block Level 01 Layout

The HVAC systems in F Block consist of a combination of wall mounted and under-ceiling type split units that cool the classrooms. There are no fresh air fans installed to F Block. The F Block classrooms rely on natural cross ventilation to ensure adequate fresh air supply to the classrooms, with openable windows on opposite sides of the classrooms.

During the inspection of F Block, CO₂ levels under 800 ppm were noted in all the classrooms, with the exemption of R10F101 and R10F102 with CO₂ levels readings of 1240 ppm and 1030 ppm respectively.

The air conditioning units in R10F101 and R10F102 were turned off. R10F101 had the windows closed and door opened whereas R10F102 had the door closed and 5% of windows opened. It is believed that the lack of outside fresh air naturally ventilating the classrooms resulted in the higher CO₂ levels. The other classrooms with CO₂ levels under 800 ppm had larger percentages of windows opened and / or the door opened which allowed outside fresh air to provide air movement in the classrooms.

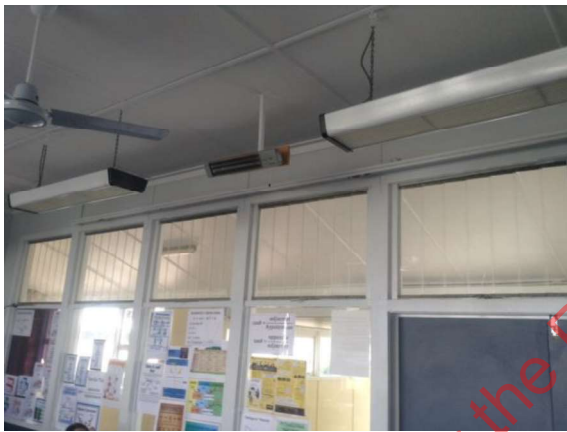
Figure 1 – A Block Under Ceiling Heater Bar

The HVAC systems in A Block consist of under ceiling split air conditioning units that cool the classrooms and wall mounted filter / fan units, interlocked with the air conditioning units, that supply outside air to the classrooms when running. The only exception to this arrangement is R100A08 where room contains 3 heater bars suspended from ceiling and a wall mounted filter / fan unit.

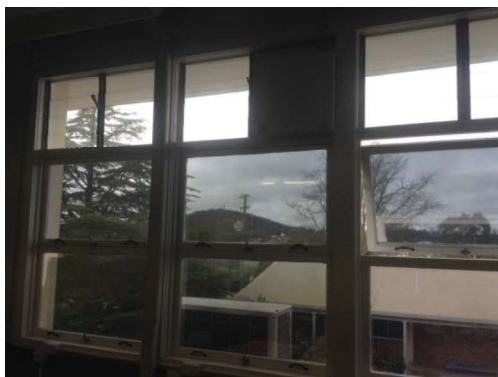
Figure 3 – A Block Level 1 South-East Window Arrangement

Windows on the South-East façade of Level 1 classrooms of A Block typically consist of awning windows (2 row by 3-5 column configuration) and louvre windows at high level. It must be noted that opening of some awning windows on the bottom row are restricted by the position of the classroom's air conditioning outdoor condenser units as shown in Figure 3. Although the opening of awning windows on the bottom row are limited, other windows on that façade can easily be opened to allow outside air to flow into the room and provide air movement into rooms.

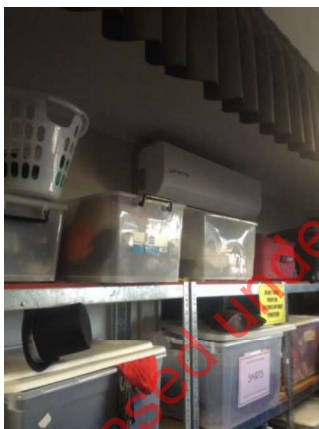
Figure 4 – C Block Wall mounted Split Indoor Unit

The HVAC systems in C Block consist of under ceiling split air conditioning units that cool the classrooms and wall mounted filter / fan units, interlocked with the air conditioning units, that supply outside air to the classrooms when running. The only exception to this arrangement is RG0CL01 where the room contains wall mounted split air conditioning systems without any fresh air ventilation fan.

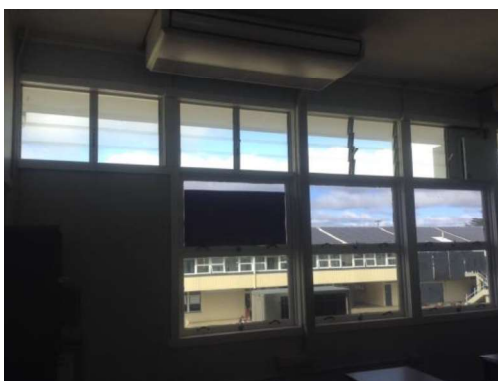
Figure 6 – C Block Level 1 South-East Window Arrangement

The window arrangement on the South-East façade of Level 1 classrooms of C Block are similar to A Block, and as noted in A Block, the opening of some awning windows on the bottom row in classrooms of C Block is restricted by the location of the room's air conditioning outdoor condenser unit. Other windows on that façade can be easily opened to allow outside air to naturally flow into the room.

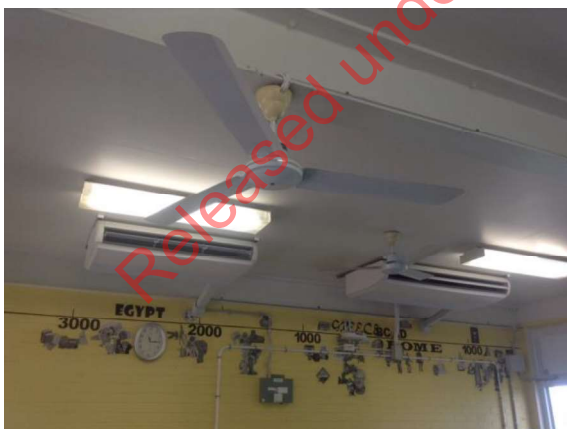
Figure 7 – E Block RG0DL01 under ceiling Indoor Unit

At the time of inspection, it must be noted that RG0DL01 and RD0GL03 had all the windows closed whereas other classrooms in E Block had more than 25% of windows opened. It is suspected that the opened door in RD0GL03 allowed outside fresh air to enter the room which kept the CO₂ level under 800 ppm. The same could not be said for RG0DL01 as it did not have the door opened. Furthermore, although the air conditioning units and fans were operational in RG0DL01, the absence of relief paths to outside could have resulted in a higher CO₂ level reading.

In RG0DL01, we recommend the vertical sliding windows are repaired to allow for easy opening by staff and students.

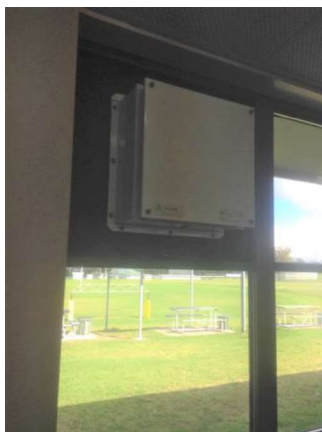
Figure 9 – M Block RG00M02 mounted Split Indoor Unit

The HVAC systems in M Block consist of wall mounted split air conditioning units that cool the classrooms and wall mounted filter / fan units, interlocked with the air conditioning units, that supply outside air to the classrooms when running.

It is further recommended that the operation of the mechanical ventilation systems serving M Block Science Labs and D Block Music Prac Room be verified, and the fans replaced or repaired where necessary.

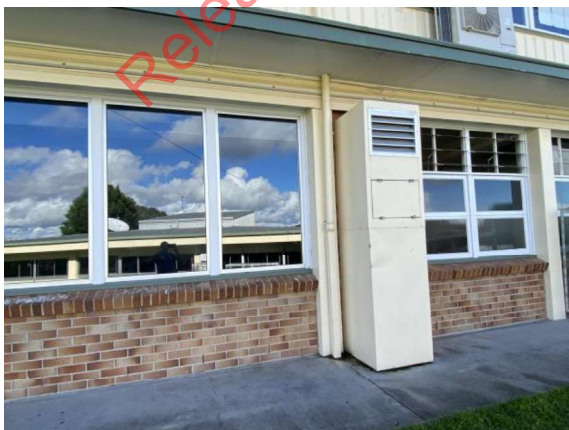
Figure 11 – RG0DL02 Ventilation Fan

During the inspection of D Block, RG0DL02 (Music Prac Room), it was noted that the classroom windows were not openable. It is suspected that the windows were fixed in order to limit noise egress during rehearsals. A mechanical ventilation system is installed, comprising an acoustically treated ducted ventilation fan supplying air to the room, and an air relief louvre on the opposite façade with an internally lined duct to limit noise transfer.
