# Infrastructure Services Hot Issues Brief

<b>Topic:</b>	<b>Storm Damage – 7 November 2015</b>	<b>Action officer:</b>	<b>Barbara Kropp</b>
<b>Date:</b>	<b>9 November 2015</b>	<b>Accountable Director:</b>	<b>Maree Bauer</b>

Parsons Brinckerhoff Australia Pty Limited

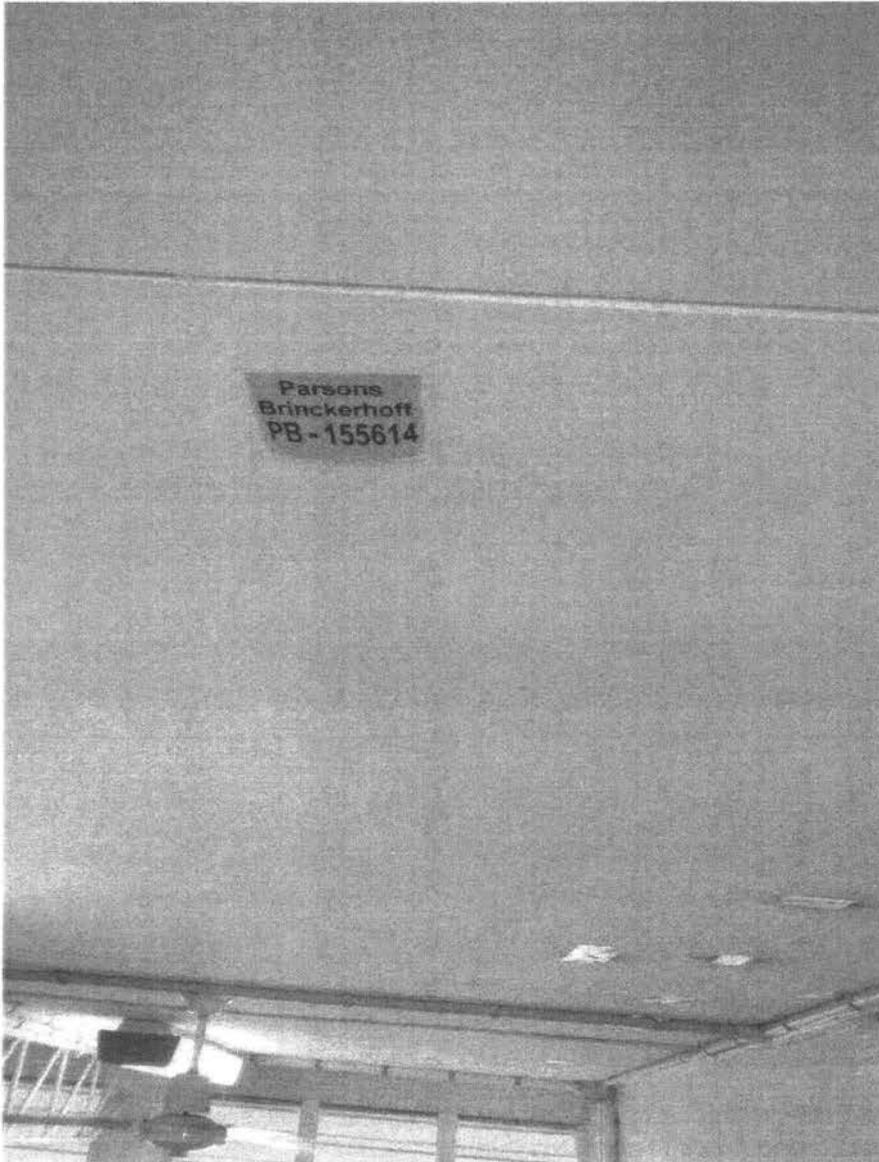
- Furthermore, hangers for the ceiling fans penetrated through the Low Density Board (LDB) ceiling. These edges- were not sealed leaving a raw sheet edge. This was real concern as the vibration movement of a fan may cause the release of friable fibres from the raw edge of the sheet to be circulated throughout the classroom via the ceiling fans. (Photos attached – **Attachment 1**).

Sample PB-155614 Low density board ceiling in Room B6

Additional to the options outlined above Parsons Brinckerhoff would recommend that consideration be given to removing the low density board ceiling and replacing the ceiling with a non-asbestos product.

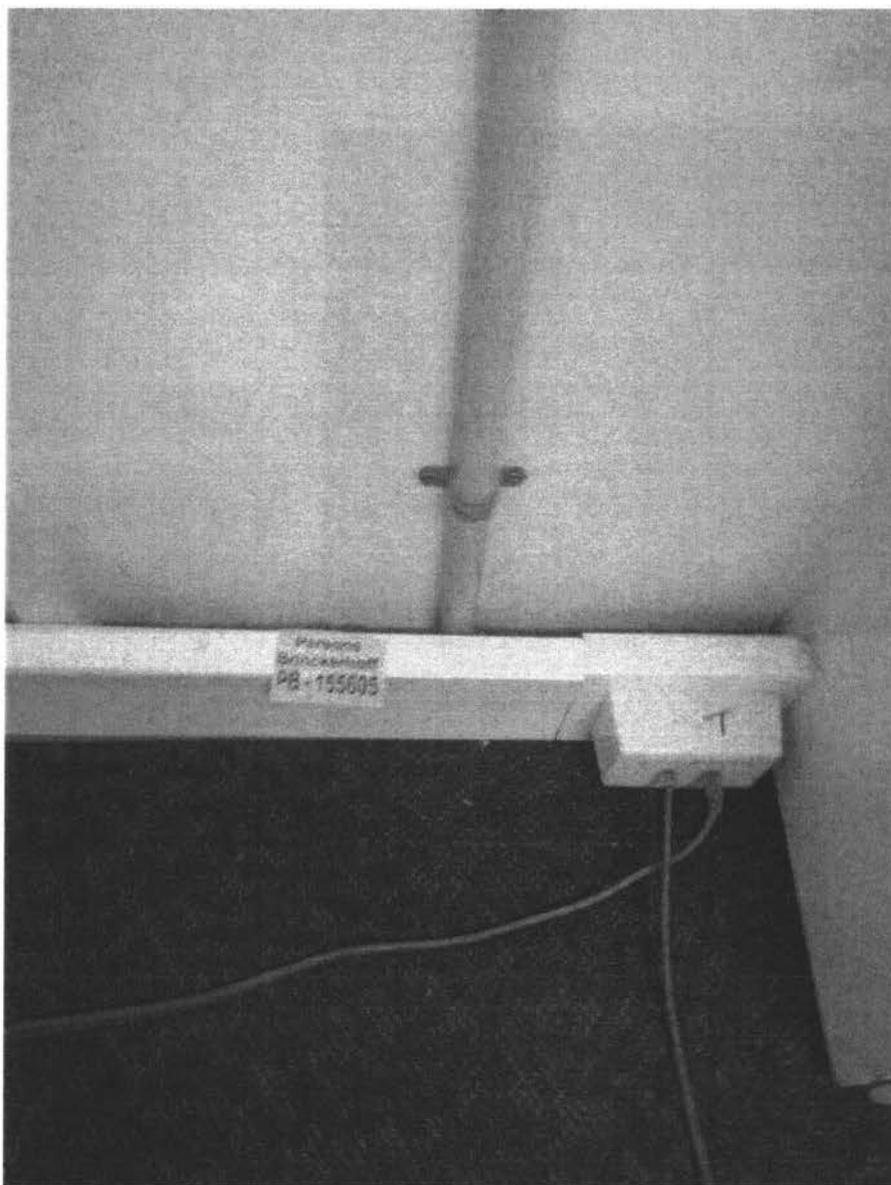
**Sample PB-155605 Electrical/data skirting conduit along base of western wall, south-western corner. Dust found to contain Chrysotile and Amosite asbestos fibres.**

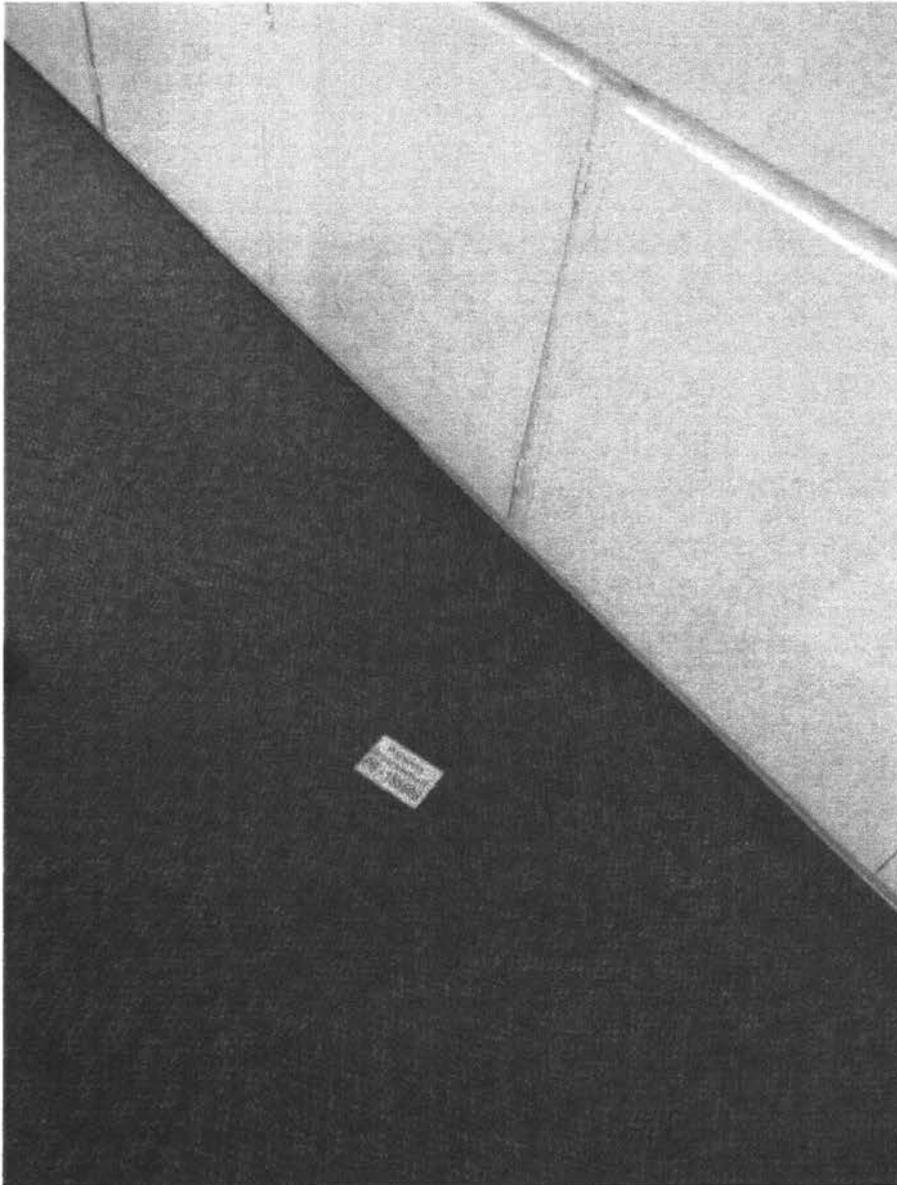
**Sample PB-155608 Carpet in front of whiteboard cupboard under ceiling penetrations, centre section.  
Dust found to contain Chrysotile asbestos fibres.**

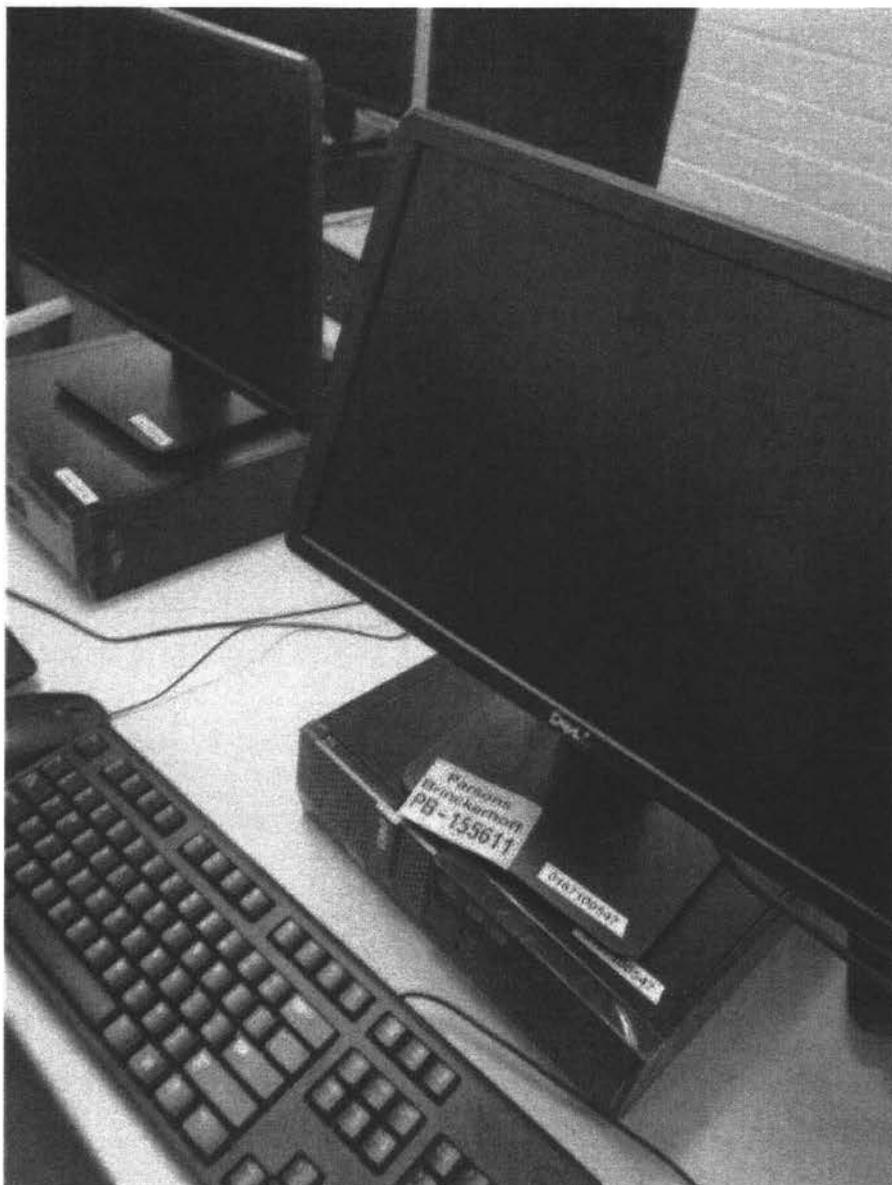
**Sample PB-155611 Top of computers, south-western corner under ceiling penetrations and conduits. Dust found to contain Chrysotile and Amosite asbestos fibres.**

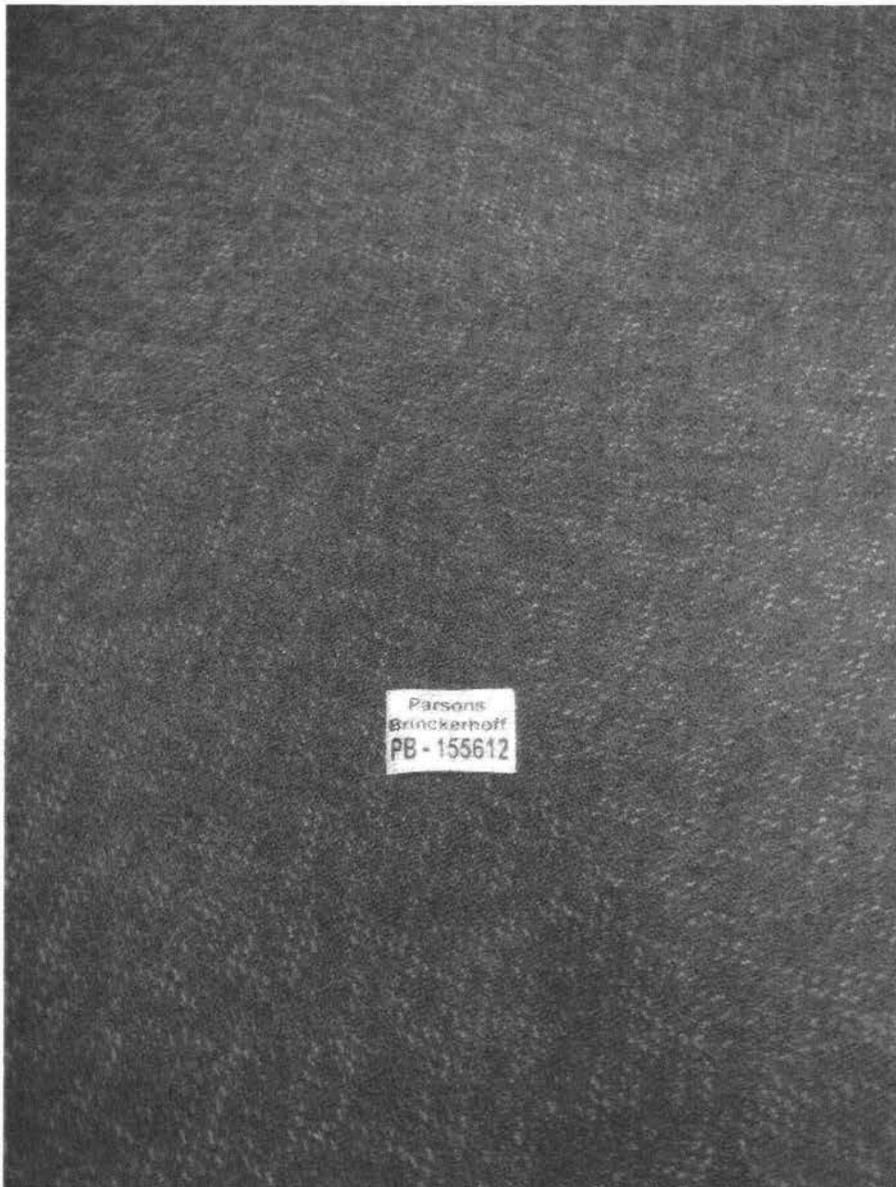
Sample PB-155612 Carpet under penetrations, north-eastern corner. Dust found to contain Chrysotile asbestos fibres.

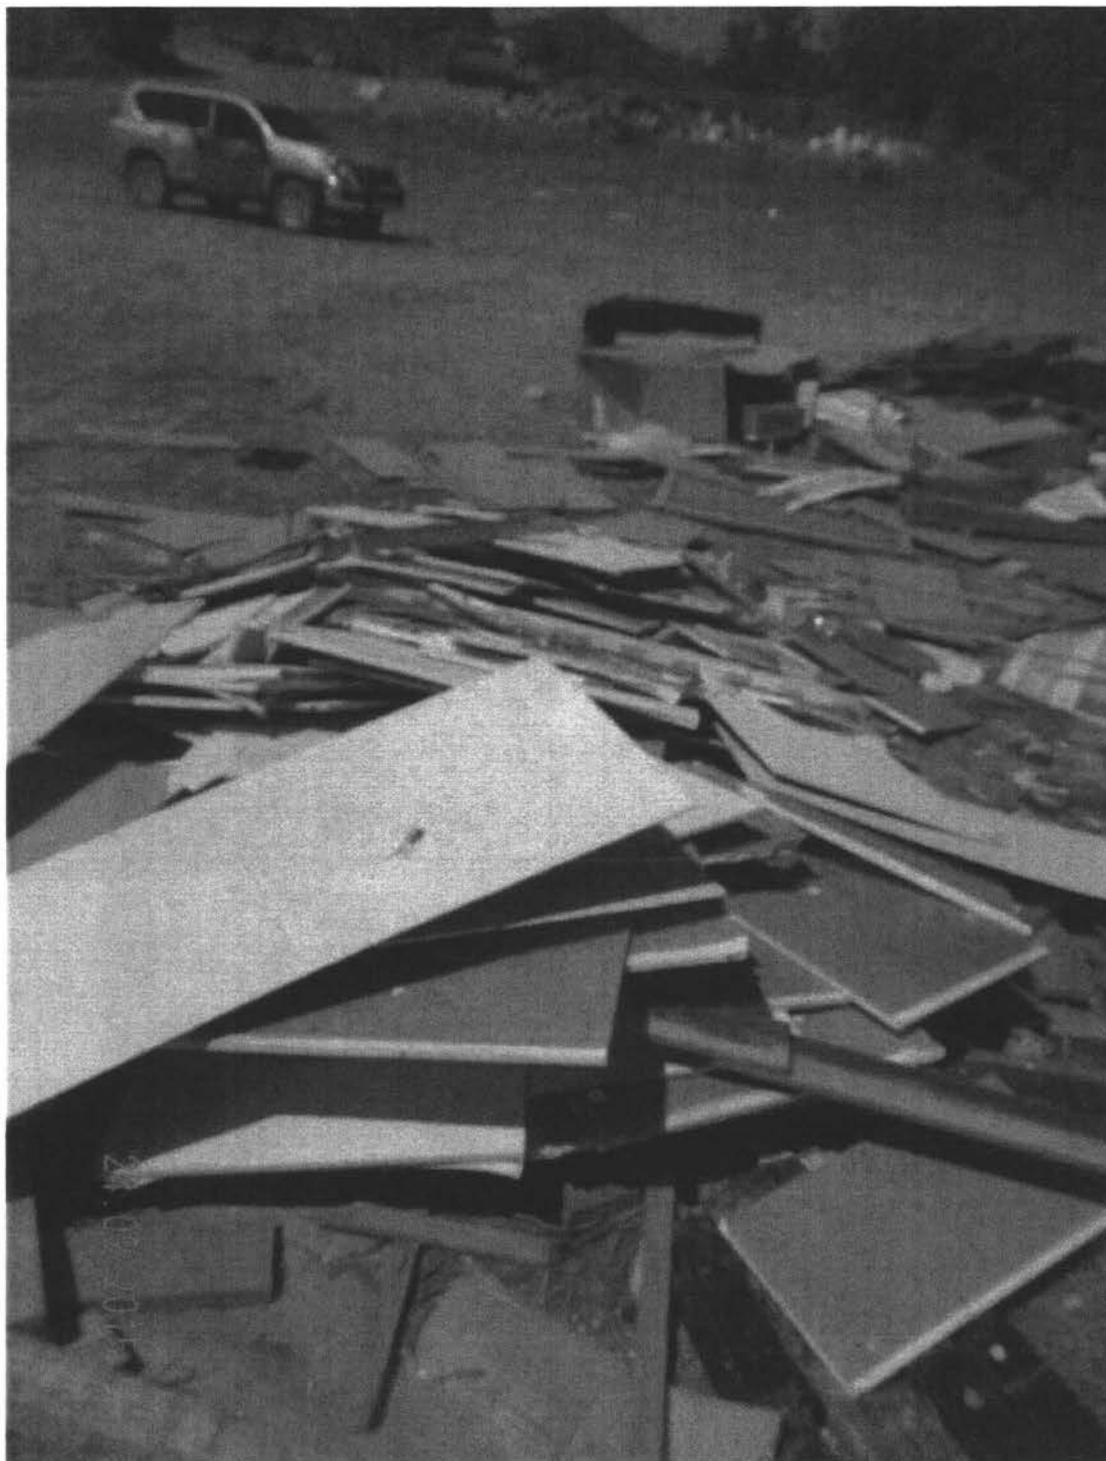
- Lower northern section (green waste dumping area) has similar building debris as found in the upper hill section. These materials are consistent with materials removed from the Kindergarten. There is a blue and white patterned Tilux sheeting present, slightly away in another pile of trade waste debris that would appear to be generated by other persons. There does not appear to be any evidence of this colour Tilux having being present in any of the areas within the Kindergarten.

Example of builders waste found in the lower northern section of the Sch. 30 landfill

1. Until such time as the waste can be removed under controlled conditions all existing debris is to be cordoned off and covered to prevent accidental disturbance or disposal.

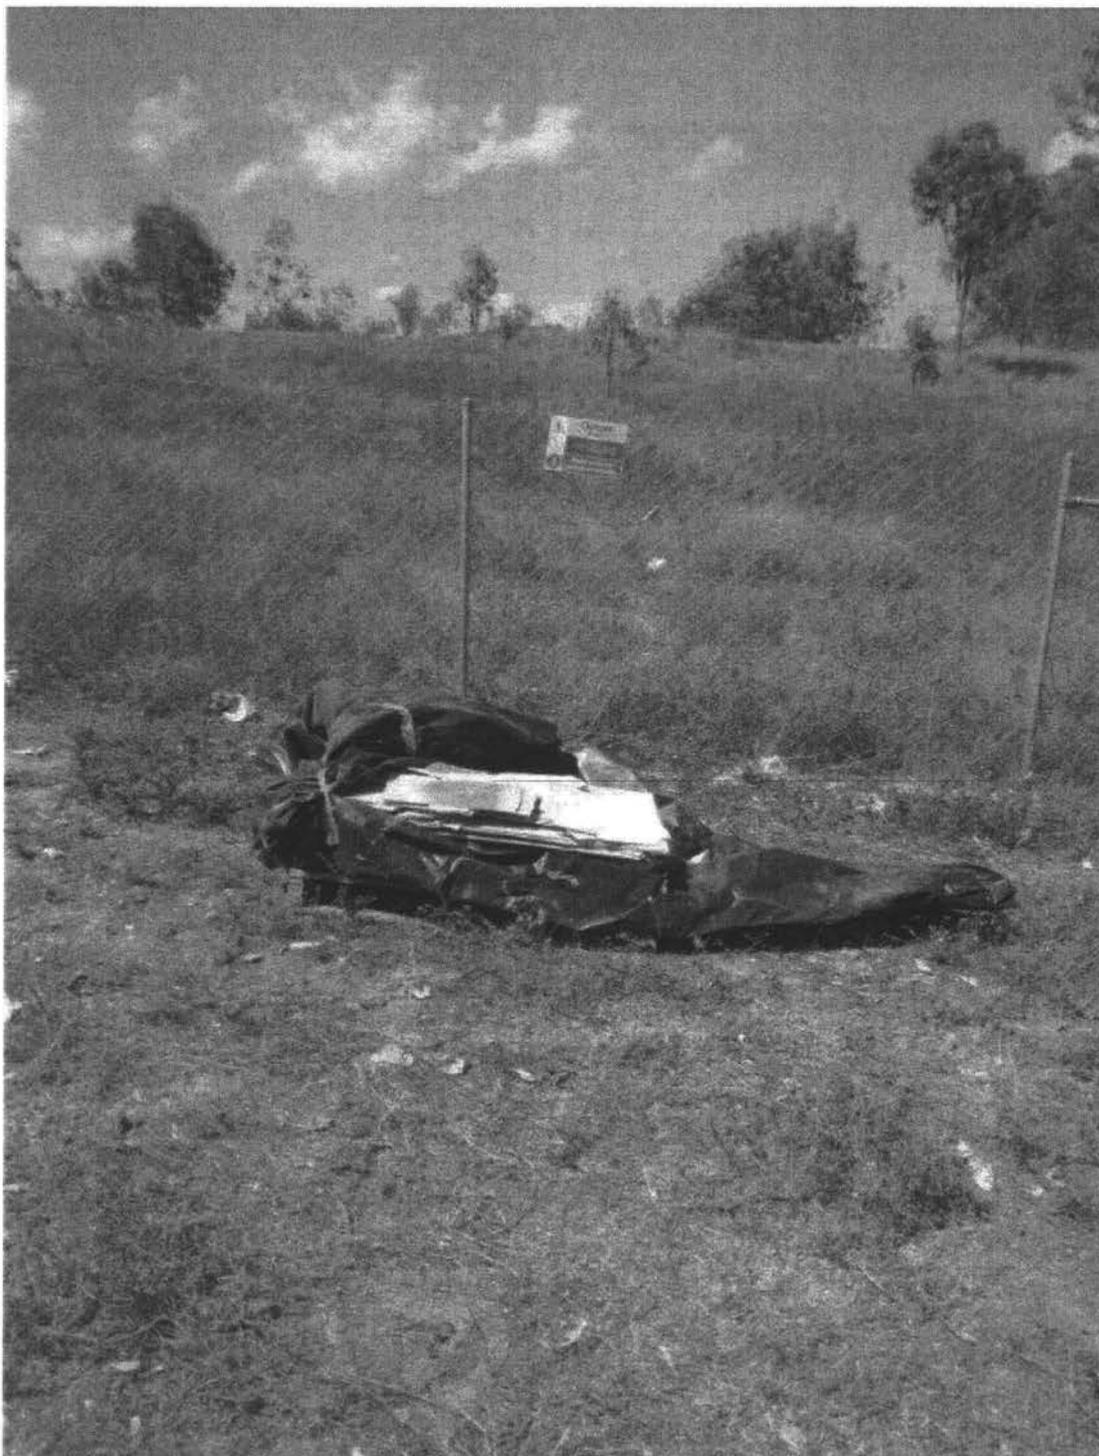
- Lower southern section which is isolated and where a poorly wrapped bundle of asbestos cement ceiling tiles are stored. No samples were taken as they were of the same appearance as the ceiling tiles found in the upper hill section.

Poorly package builders waste found in the lower southern section of the Sch. 3 landfill

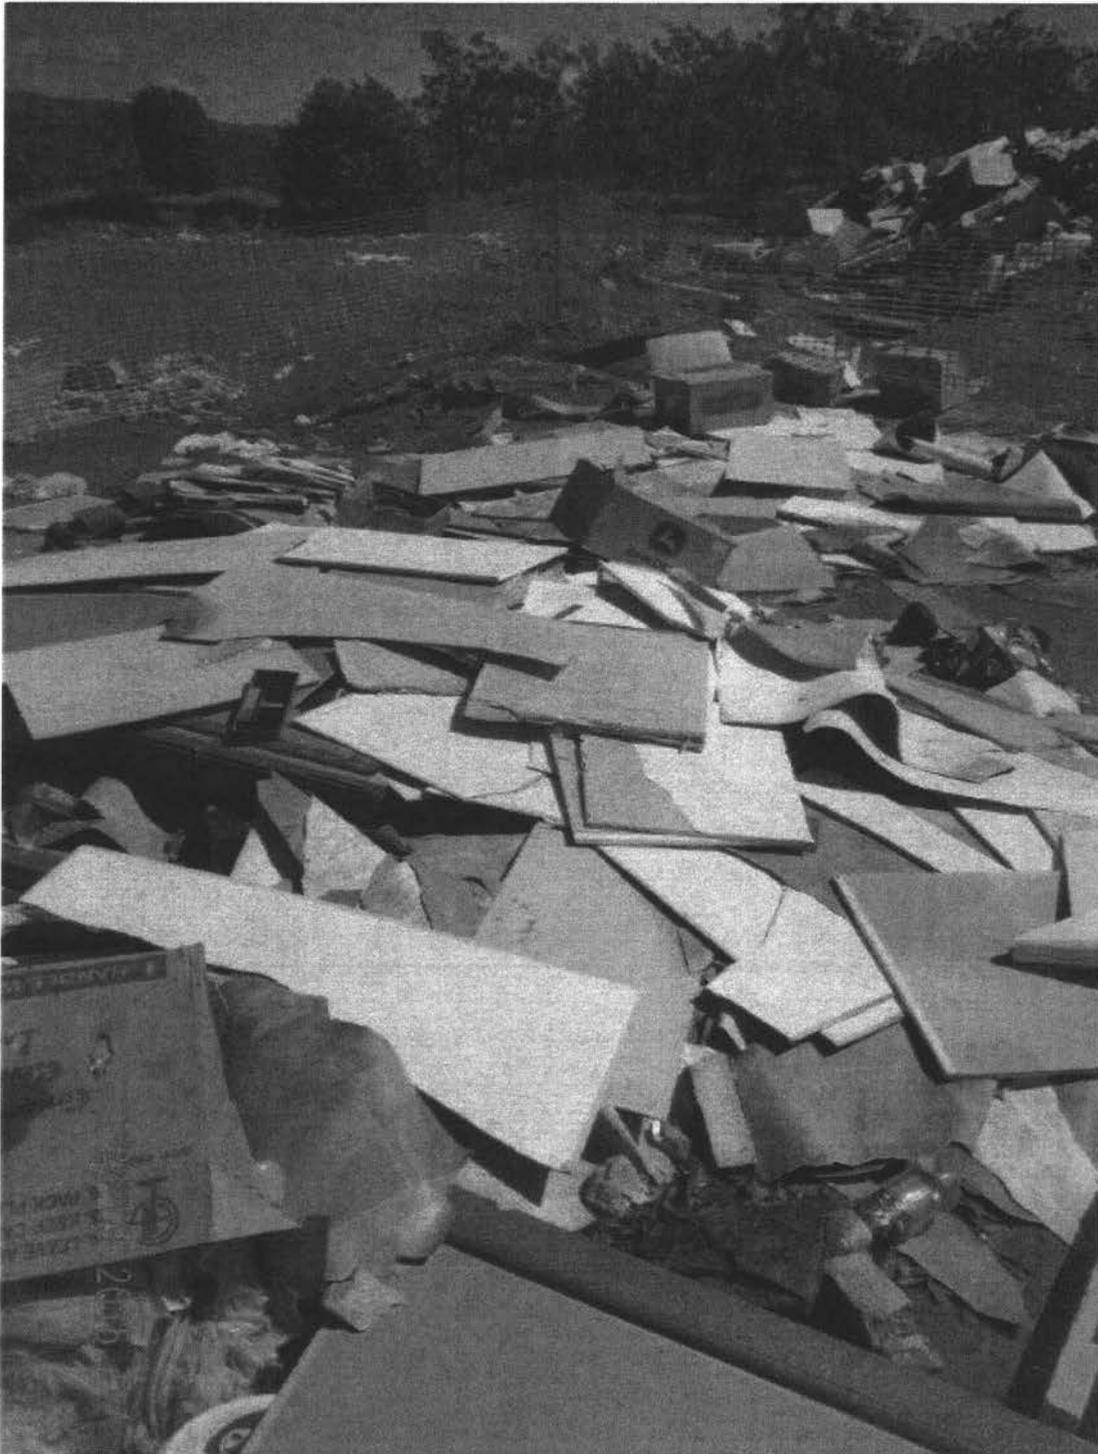
Example of builders waste found in the upper hill section of the Sch. 3 landfill

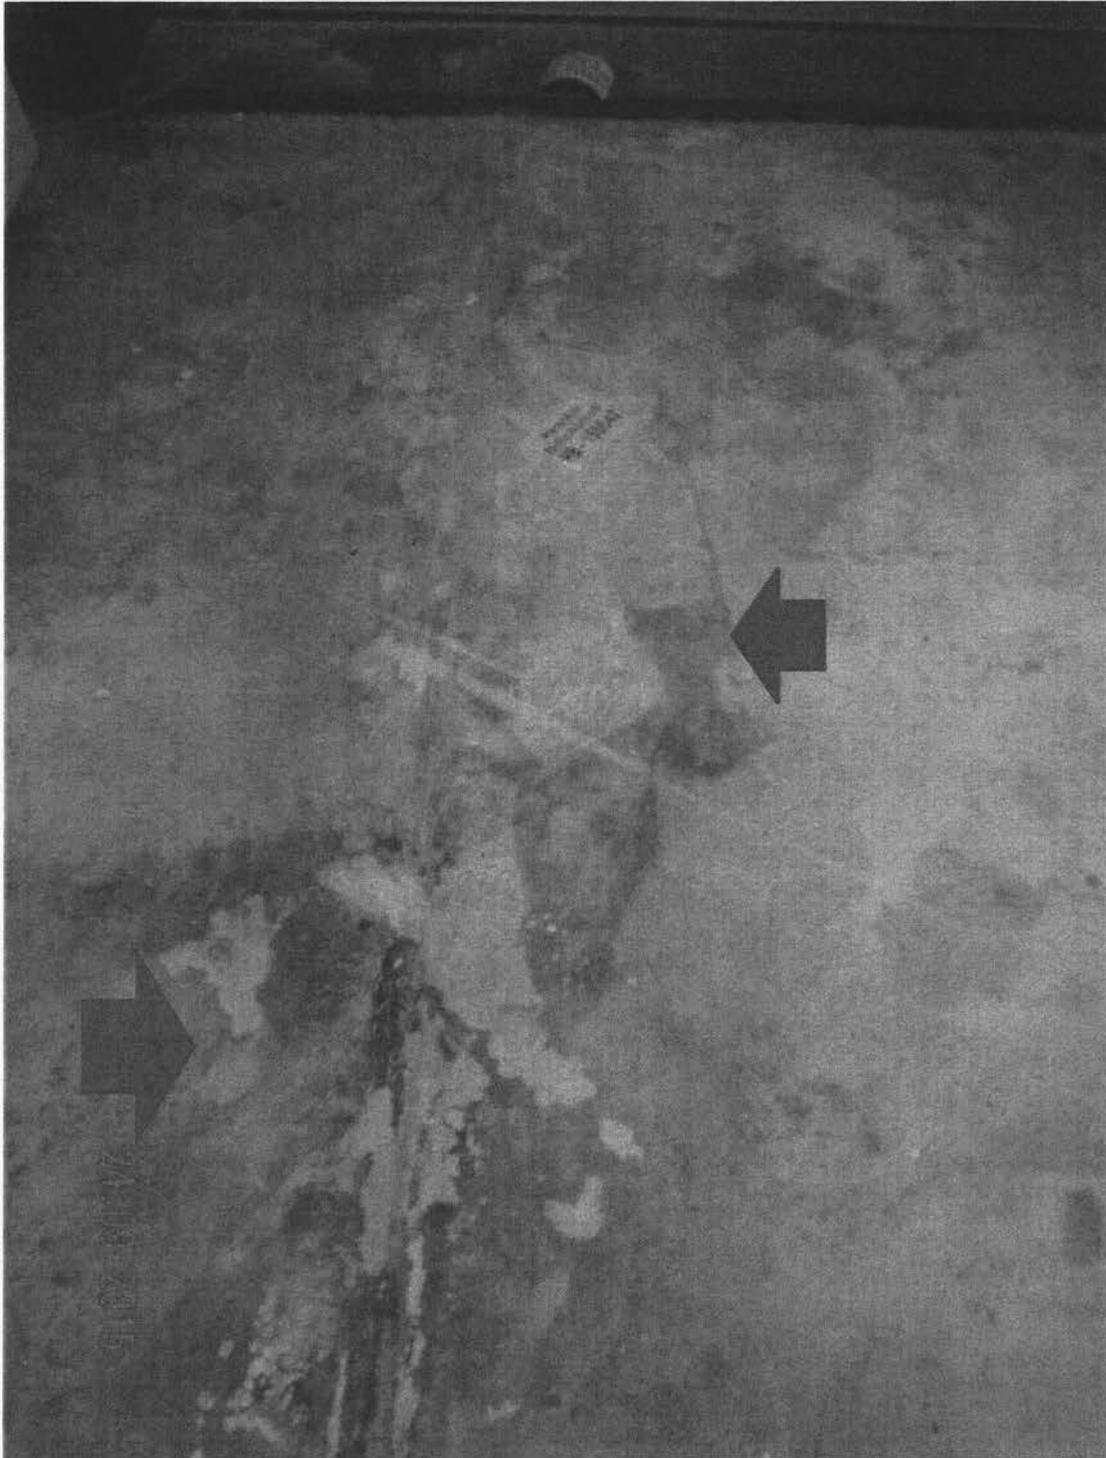
Millboard backing found on the concrete substrate floor within the Sch. 30 Kindergarten

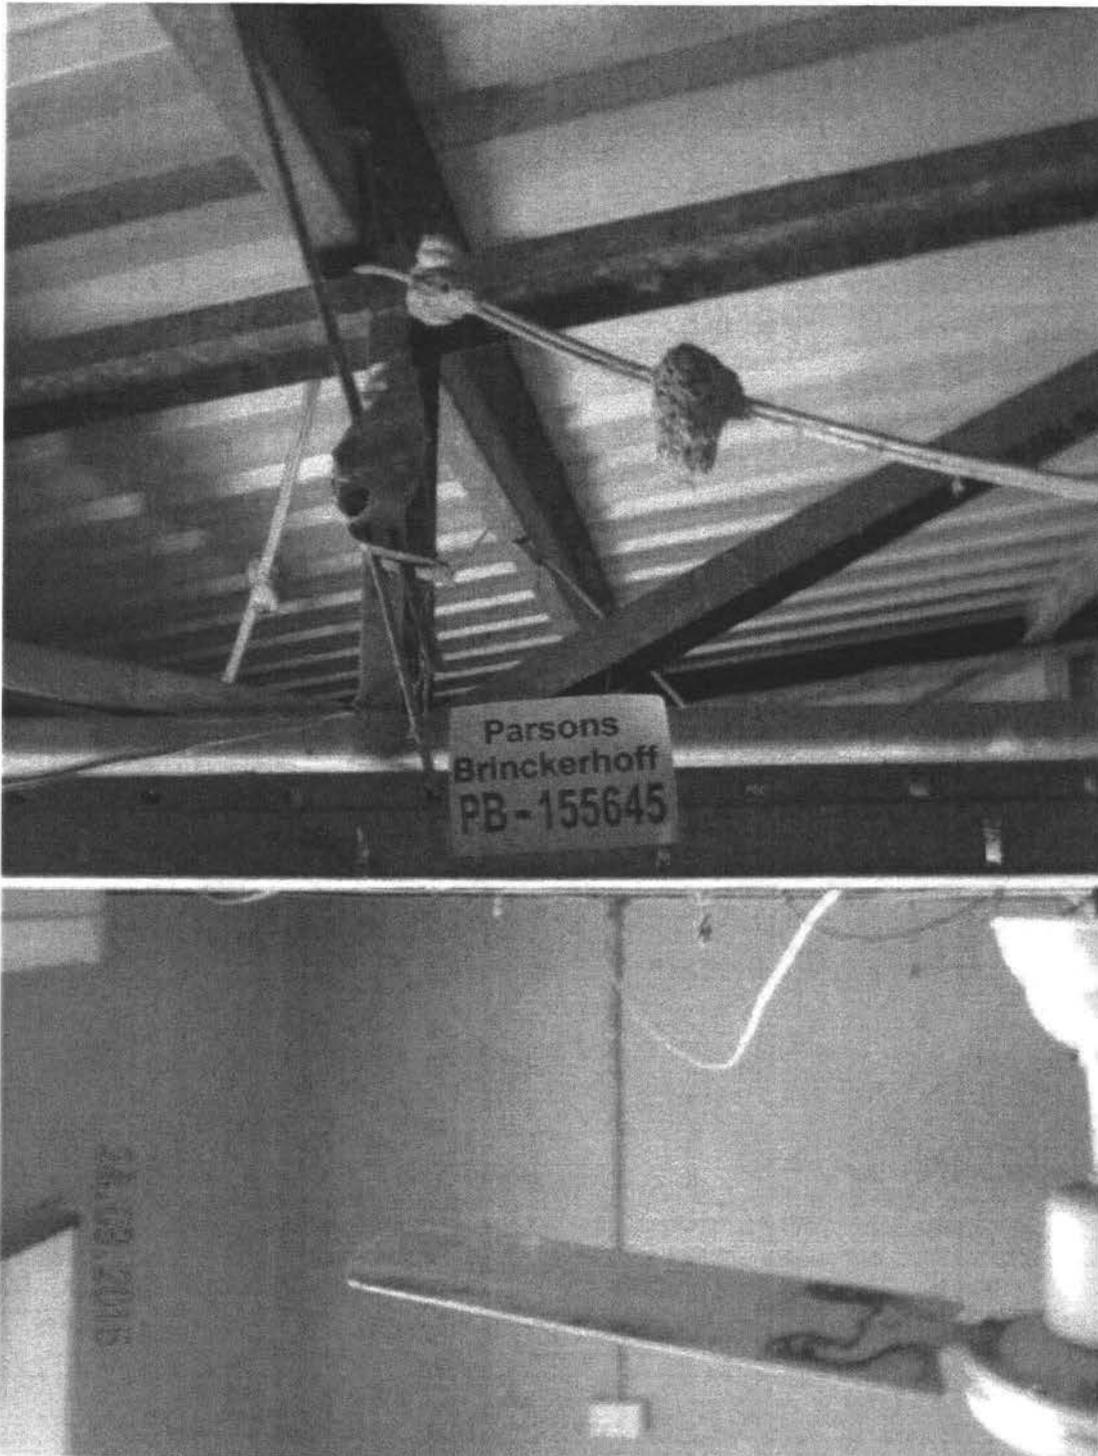
Sample PB-155645 remaining suspended ceiling frame found to be contaminated with asbestos containing dust
