Ventilation Survey

Moorooka State School

Department of Education

28 October 2022

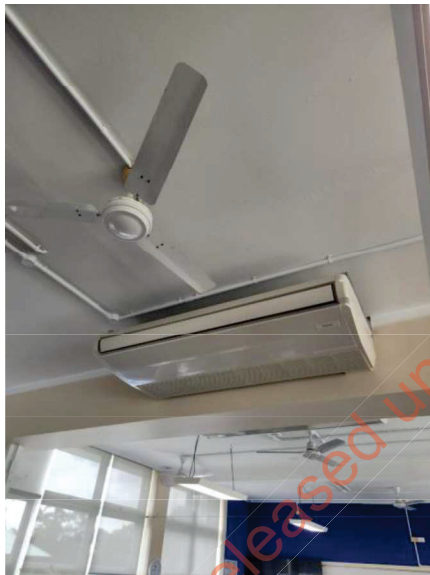
Figure 2 – R10D101 AC Unit

Each classroom utilises two under ceiling direct expansion (DX) air conditioning units that cool and heat the classrooms and wall mounted filter / fan units, interlocked with the air conditioning units, that supply outside air to the classrooms when running. The air conditioning units and wall mounted filter / fan units were not running in R10D101 & R20D206 at the time of the inspection.

Air-conditioning should also be used where fresh air fans are installed to ensure they are running during lessons. At least one window or louvre opposite the fresh air fans should be left partially open to improve the efficiency of the fan and promote adequate cross ventilation of the room. It is further recommended that all fresh air fan filters are cleaned to ensure optimum performance of all fan units.

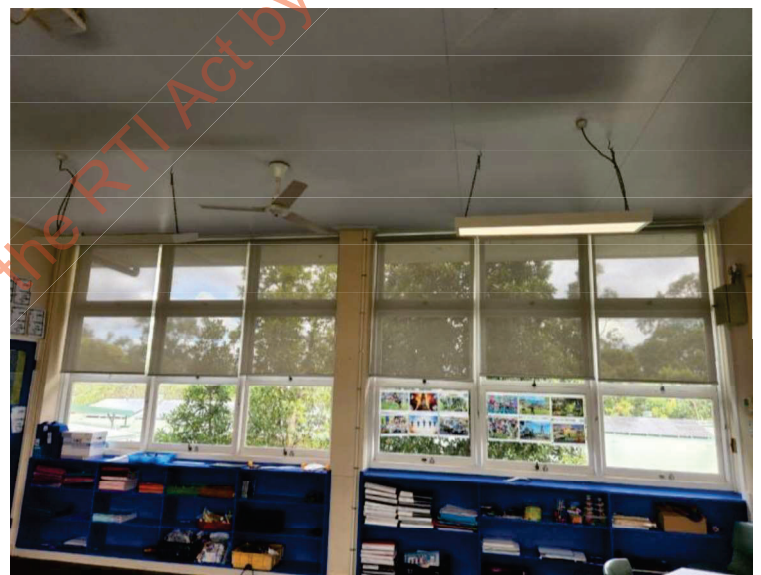
Figure 3 – R20D206 External Window

Cross ventilation is available in both R10D101 & R20D206 as openable windows and doors are located on the opposite sides of the room. R10D101 was the only classroom to utilise cross ventilation at the time of inspection and as a result a CO₂ level under 800 ppm was observed. It must be noted that one of the two doors and all windows were closed in R20D206.

A CO₂ level of 1068 ppm was recorded in R20D206 with closed doors, closed windows and an unused HVAC system. It is suspected that the lack of natural and mechanical ventilation resulted in the high CO₂ level observed.

It is recommended that at least some classroom windows, and where feasible the classroom doors, are kept open during lessons in order to promote cross ventilation. If low level windows are not opened due to the safety of the students, it is recommended that high-level windows be used where required.

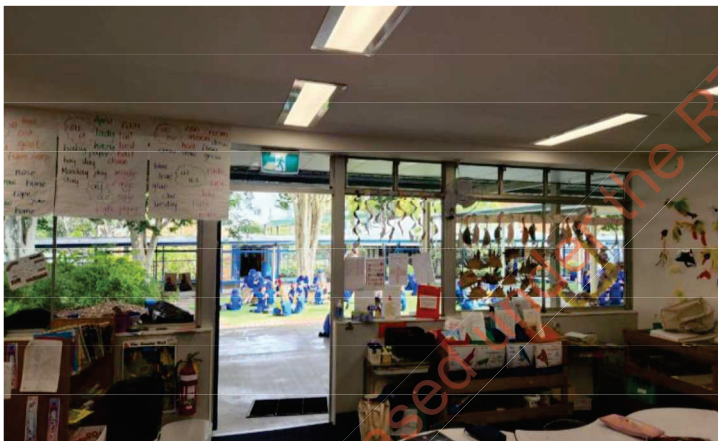
Figure 5 – Classroom Year 1B External Windows

At the time of inspection, cross ventilation was utilised in the Zen room as external doors were opened which contributed to the lowest CO₂ level observed in E Block. It was noted that external doors were opened in classrooms Year 1A, Year 1B, Year 1C and Year 2A. All windows and doors were closed in Year 2C classroom.

CO₂ levels over 800 ppm were recorded in more than half of classrooms inspected. Although the external door was opened in each classroom except for the Year 2C classroom, the opening was insufficient to ensure air movement through each classroom. It is suspected that the lack of outside air via natural and mechanical ventilation in the classrooms resulted in the high CO₂ levels observed.

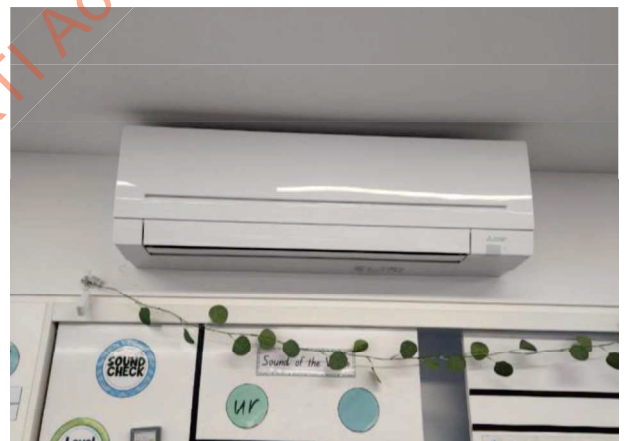
Figure 6 – Classroom Year 1A AC Unit

Each classroom utilises a single wall mounted DX air conditioning unit that cools and heats the classroom. It was noted that there was no indication of outside air fan systems in any of the classrooms. The air conditioning unit was running in the Year 1C classroom at the time of inspection. It is believed the combination of the air conditioning unit running and opened external door in Year 1C classroom promoted sufficient air movement in the classroom which resulted in a CO₂ level under 800 ppm.

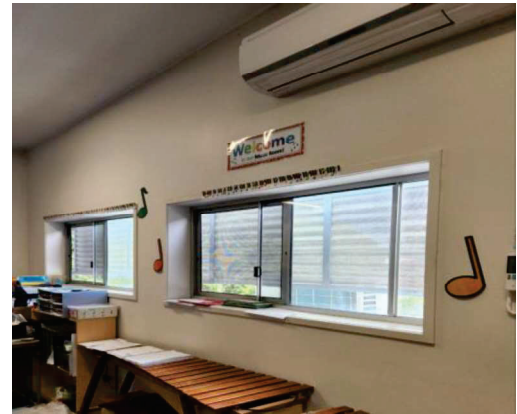
Figure 11 – R10J101 External Wall and AC Unit

A wall mounted DX air conditioning unit that cools and heats the classroom is utilised in each classroom. No outside air fan units are installed in any of the classrooms and therefore outside air cannot be mechanically ventilated into the classrooms. Air conditioning units were not running in both classrooms at the time of the inspection.

CO₂ levels over 800 ppm were observed with levels of 1375 ppm and 910 ppm in R10J101 and R10J103 respectively. Although several windows were open in each classroom, it is suspected that the classrooms' musical activities combined with the absence of a mechanical ventilation systems, resulted in the high CO₂ levels recorded.

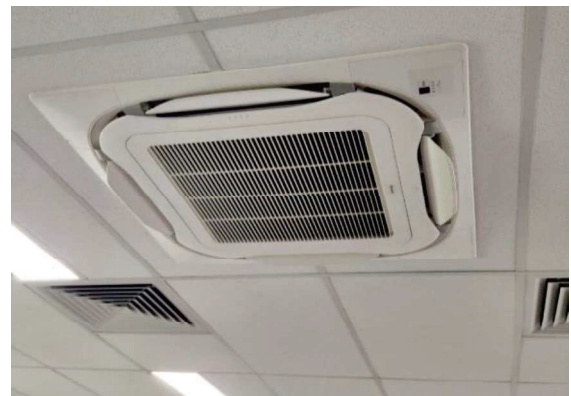
Figure 13 – Prep D HVAC System

Each classroom utilises a ceiling mounted cassette DX air conditioning unit that cools and heats the classroom. It is suspected that a dedicated outside air fan unit is interlocked with each air conditioning unit, and supplies outside air to the classrooms through a ceiling diffuser when the air conditioning unit is running. It was noted that HVAC systems were not running in both classrooms.
