Ventilation Survey

Graceville State School

Department of Education

13 April 2022

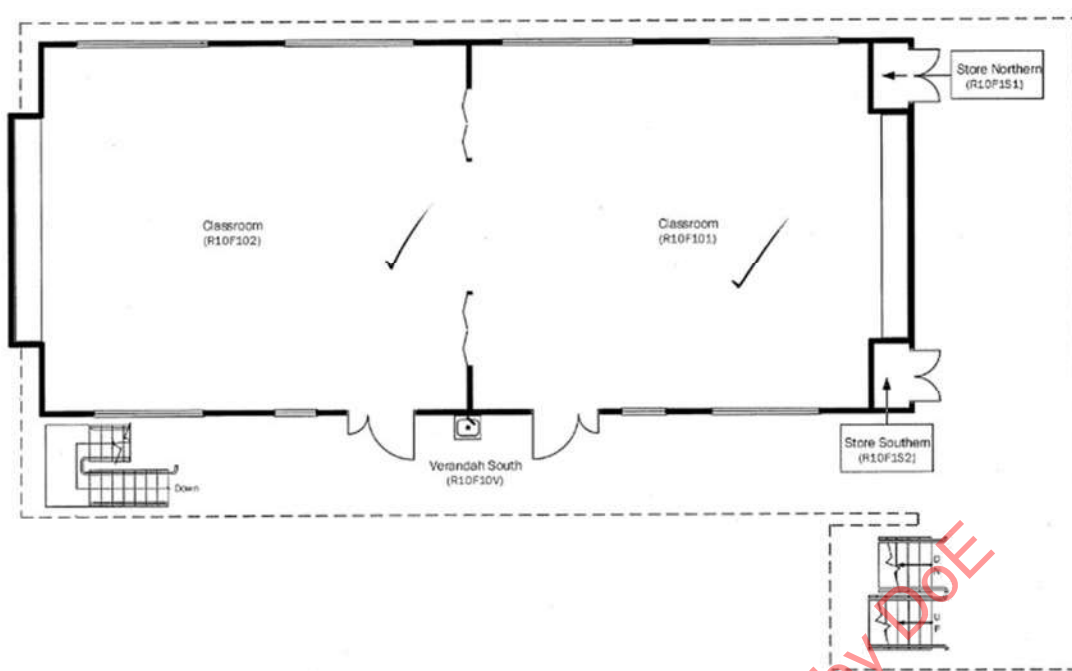
6 – F Block Level 01 Layout

During the inspection of F Block, CO₂ levels under 800 ppm were noted in all the classrooms, with the exemption of R10F101 and R10F102 with CO₂ levels readings of 1240 ppm and 1030 ppm respectively.

The air conditioning units in R10F101 and R10F102 were turned off. R10F101 had the windows closed and door opened whereas R10F102 had the door closed and 5% of windows opened. It is believed that the lack of outside fresh air naturally ventilating the classrooms resulted in the higher CO₂ levels. The other classrooms with CO₂ levels under 800 ppm had larger percentages of windows opened and / or the door opened which allowed outside fresh air to provide air movement in the classrooms.
