***Infrastructure Services
Division***

TO: DIRECTOR, FACILITIES SERVICES BRANCH,
FROM: CHIEF FACILITIES OFFICER, STRATEGIC FACILITIES BRANCH,
SUBJECT: SAFETY GLASS/FILM TRIAL 2006/07

Summary and recommendations - Safety Glass Retrofit Program in Schools

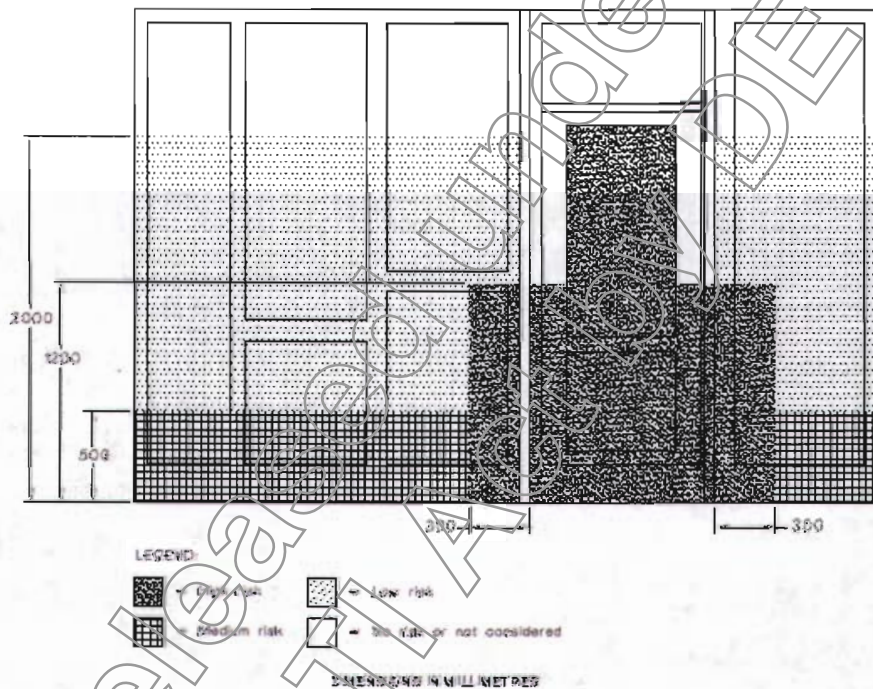
FIGURE 5.1 CRITICAL LOCATIONS

2. Accident statistics show that glazing in some locations in buildings is more vulnerable to human impact than in others. These critical locations, some of which are shown in Figure 5.1, include the following:

- (a) In and around doors (particularly in side panels which may be mistaken for doors).
- (b) Panels mistaken for a doorway or opening.
- (c) Panels at low levels in walls and partitions.
- (d) Bathrooms, spa rooms and ensuites.
- (e) Buildings associated with special activities, e.g., gymnasias, enclosed swimming pools, etc,
- (f) **Schools and child care facilities.**
